**Flood Control Project Maintenance
Levee Inspections**

Maintenance Issue Types Only, Levee Inspection Report By Mile - Spring 2017

Reclamation District No. 0524 Middle Roberts Island

Waterway	Bank	Unit Miles	Inspection Start/End	Inspector
Unit No. 01 San Joaquin River	Left	6.20	04/04/2017 04/05/2017	Richard Willoughby

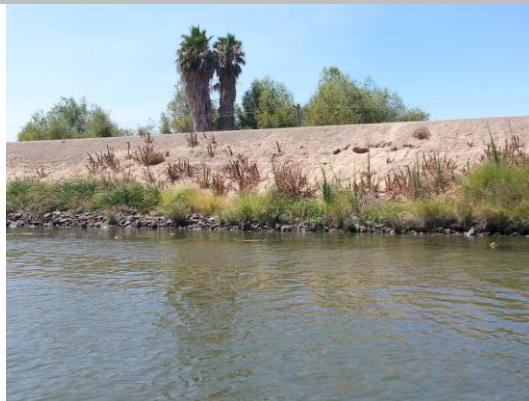
Photo 3 of 3 : SP_2017_RD0524_107_5_20170316_00013.jpg

LM Start	0.19	Rating **	U	Issue No.	5 (cont)	
LM End	0.19	Issue Type +	Ma	Location *	WS	
Category	Supplemental			GPS Latitude/Longitude		
				Start		End
Item	DWR Erosion Survey			37.939085 °		37.939085 °
				-121.343917 °		-121.343917 °
DWR ID	DWR_RD0524_01_s _ 2017_5					
Comment Code						
Inspector Comment						
07/25/2016: No significant change observed.						
06/24/2015: No significant change observed.						
06/19/2014: No significant change observed.						
08/13/2013: The erosion was discovered during 2013 spring levee inspection. Inspector comment: Erosion is located along the lower level of water-ward slope. [2016 Site ID:RD0524U01RM40.85]

Close view of the erosion.

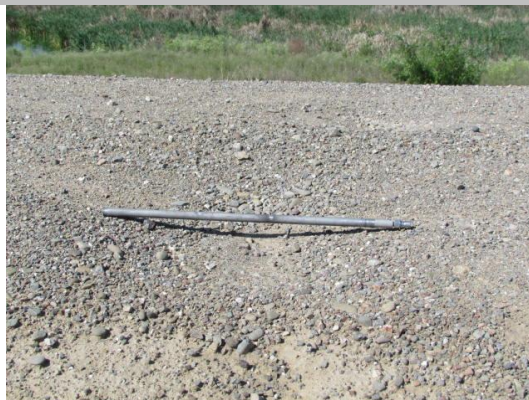
Photo 1 of 3 : SP_2017_RD0524_107_3_20170316_00007.jpg

LM Start	0.21	Rating **	M	Issue No.	3
LM End	0.21	Issue Type +	Ma	Location *	CR
Category	Earthen Levee			GPS Latitude/Longitude	
				Start	End
Item	Crown Surface / Depressions / Rutting			37.938890 °	37.938890 °
				-121.343657 °	-121.343657 °
DWR ID	DWR_RD0524_01_s _ 2016_3				
Comment Code					
C2 : Repair depressions or ruts in the crown or slope.					
Inspector Comment					
No change in status.

Looking west at 3" depression on levee crown. (Spring 2012)

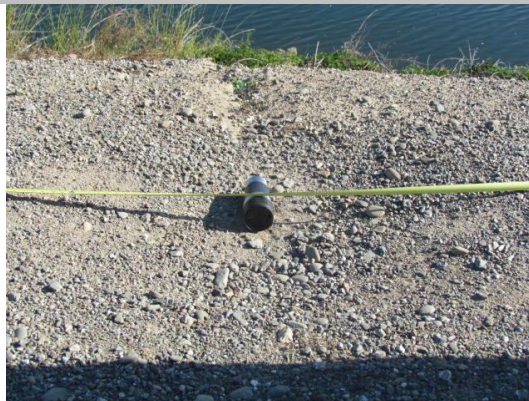
Photo 2 of 3 : SP_2017_RD0524_107_3_20170316_00008.jpg

LM Start	0.21	Rating **	M	Issue No.	3 (cont)	
LM End	0.21	Issue Type +	Ma	Location *	CR	
Category	Earthen Levee			GPS Latitude/Longitude		
				Start		End
Item	Crown Surface / Depressions / Rutting			37.938890 °		37.938890 °
				-121.343657 °		-121.343657 °
DWR ID	DWR_RD0524_01_s_2016_3					
Comment Code						
C2 : Repair depressions or ruts in the crown or slope.						
Inspector Comment						
No change in status.

Looking west at depression on levee crown near waterward shoulder.

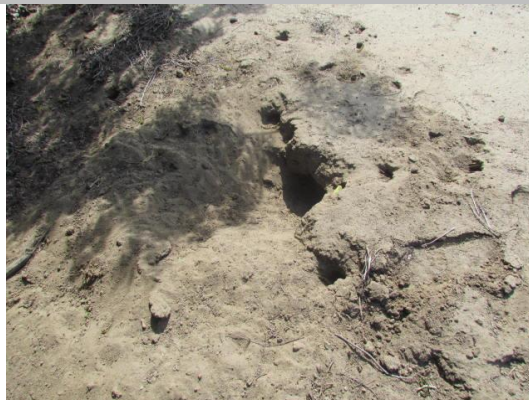
Photo 3 of 4 : SP_2017_RD0524_107_174_20170316_00206.jpg

Looking west at several rodent holes on waterward shoulder. (Spring 2015)

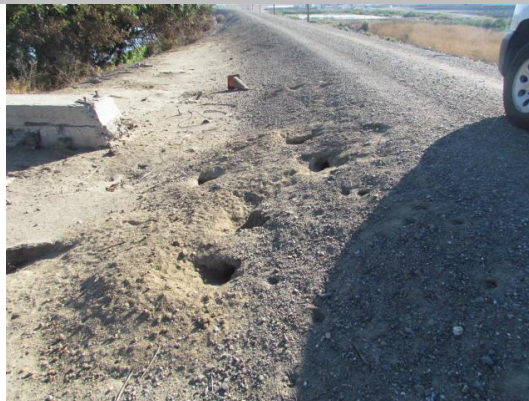
Photo 4 of 4 : SP_2017_RD0524_107_174_20170316_00207.jpg

LM Start	0.30	Rating **	U	Issue No.	174 (cont)
LM End	0.30	Issue Type +	Ma	Location *	WS
Category	Earthen Levee			GPS Latitude/Longitude	
				Start	End
Item	Animal Control			37.938382 °	37.938382 °
				-121.342352 °	-121.342352 °
DWR ID	DWR_RD0524_01_f_2014_174				
Comment Code					
A1 : Exterminate rodents and backfill and compact or grout burrows.					
Inspector Comment					
Several rodent holes present at this site. No change at site during spring 2016 inspection.					
Active rodent activity during spring 2017 inspection. No change at site.

Looking southeast at several rodent holes on waterward slope. (Fall 2015).

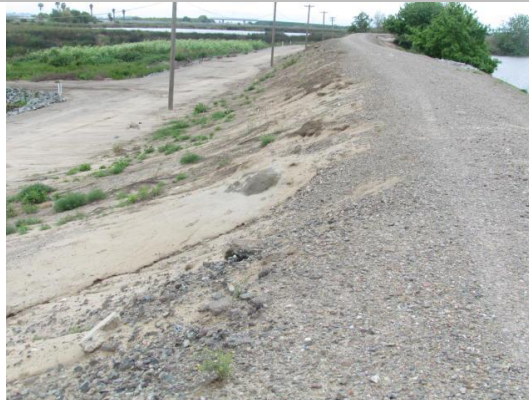
Photo 1 of 2 : SP_2017_RD0524_107_205_20170316_00237.jpg

LM Start	0.40	Rating **	U	Issue No.	205
LM End	0.46	Issue Type +	Ma	Location *	LS
Category	Earthen Levee			GPS Latitude/Longitude	
				Start	End
Item	Erosion / Bank Caving			37.938625 °	37.938695 °
				-121.340479 °	-121.339420 °
DWR ID	DWR_RD0524_01_s_2016_205				
Comment Code					
E2 : Schedule repair of erosion site prior to the next inspection.					
Inspector Comment					
Several damage site within this reach.

Looking at slope damage on landward slope.

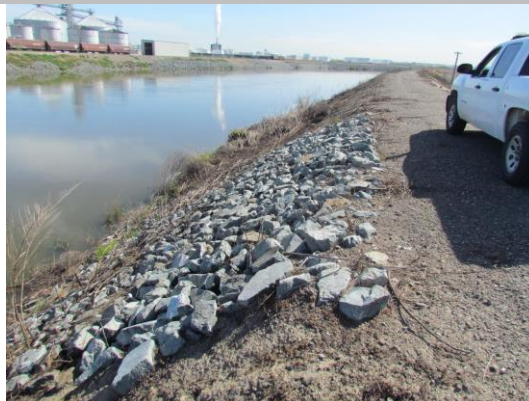
Photo 1 of 3 : SP_2017_RD0524_107_16_20170407_00379.jpg

LM Start	0.40	Rating **	A/W	Issue No.	16	
LM End	0.40	Issue Type +	Ma	Location *	WS	
Category	Supplemental			GPS Latitude/Longitude		
				Start	End	
Item	DWR Erosion Survey			37.938870 °	37.938870 °	
				-121.340460 °	-121.340460 °	
DWR ID	DWR_RD0524_01_s_2017_16					
Comment Code						
Inspector Comment						
04/04/17: Site repaired						
07/25/2016: More vegetation observed at the site.						
06/24/2015: No significant change observed.						
06/19/2014: No significant change observed.						
08/13/2013: No significant change at this site.						
08/07/2012: The erosion is at the upper levee slope, and likely caused by slope slip. The lower levee slope is covered with dense vegetation.						
[2016 Site ID:RD0524U01RM40.99]

Looking south at repaired site on waterward slope.

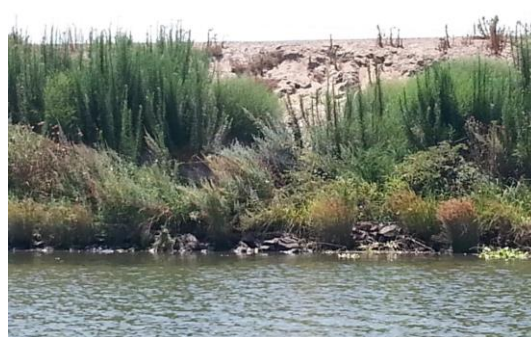
Photo 3 of 3 : SP_2017_RD0524_107_16_20170316_00034.jpg

LM Start	0.40	Rating **	A/W	Issue No.	16 (cont)	
LM End	0.40	Issue Type +	Ma	Location *	WS	
Category	Supplemental			GPS Latitude/Longitude		
				Start	End	
Item	DWR Erosion Survey			37.938870 °	37.938870 °	
				-121.340460 °	-121.340460 °	
DWR ID	DWR_RD0524_01_s_2017_16					
Comment Code						
Inspector Comment						
04/04/17: Site repaired						
07/25/2016: More vegetation observed at the site.						
06/24/2015: No significant change observed.						
06/19/2014: No significant change observed.						
08/13/2013: No significant change at this site.						
08/07/2012: The erosion is at the upper levee slope, and likely caused by slope slip. The lower levee slope is covered with dense vegetation.						
[2016 Site ID:RD0524U01RM40.99]

Close view of the erosion.

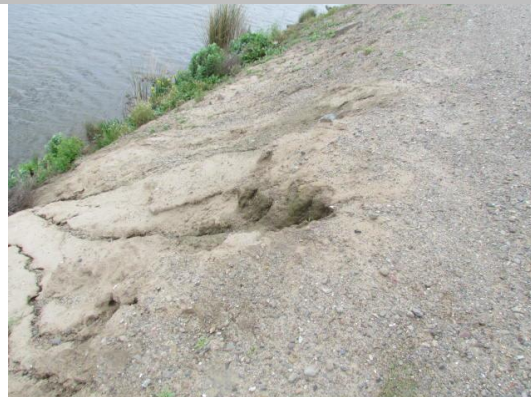
Photo 1 of 3 : SP_2017_RD0524_107_170_20170316_00197.jpg

LM Start	0.41	Rating **	U	Issue No.	170
LM End	0.45	Issue Type +	Ma	Location *	WS
Category	Earthen Levee			GPS Latitude/Longitude	
				Start	End
Item	Erosion / Bank Caving			37.938628 °	37.938688 °
				-121.340385 °	-121.339627 °
DWR ID	DWR_RD0524_01_s_2015_170				
Comment Code					
Inspector Comment					
Several slope instabilities within this reach.

Looking at slope damage on waterward shoulder (Spring 2016)

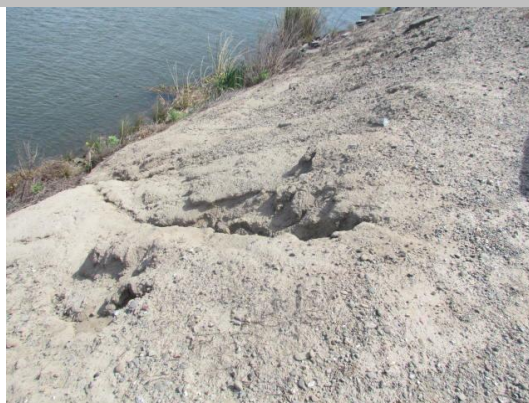
Photo 3 of 3 : SP_2017_RD0524_107_170_20170316_00199.jpg

Looking at waterward slope erosion.

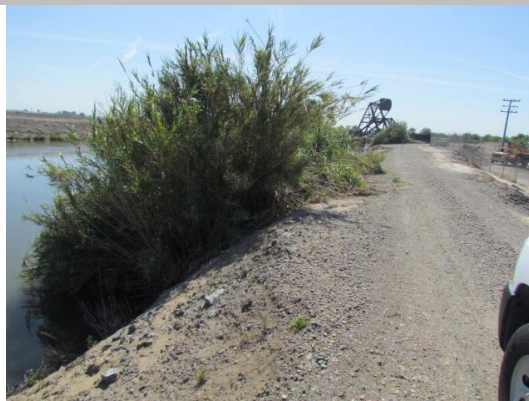
Photo 4 of 5 : SP_2017_RD0524_107_11_20170316_00023.jpg

Looking at bamboo on waterside slope. (Spring 2012)

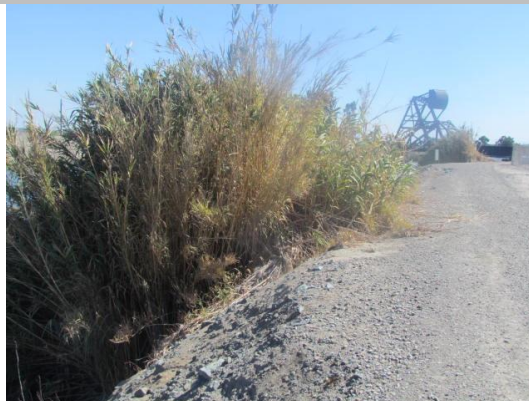
Photo 5 of 5 : SP_2017_RD0524_107_11_20170316_00024.jpg

LM Start	0.62	Rating **	U	Issue No.	11 (cont)
LM End	0.63	Issue Type +	Ma	Location *	WS
Category	Earthen Levee			GPS Latitude/Longitude	
				Start	End
Item	Vegetation			37.938278 °	37.938247 °
				-121.336524 °	-121.336503 °
DWR ID	DWR_RD0524_01_s_2012_11				
Comment Code					
V2 : Remove the wild growth other than native grasses from the levee slopes.					
Inspector Comment					
Bamboo on waterward slope. Bamboo has been killed but still blocking view of waterward slope.

Looking at bamboo on waterside slope. (Fall Inspection 2012)

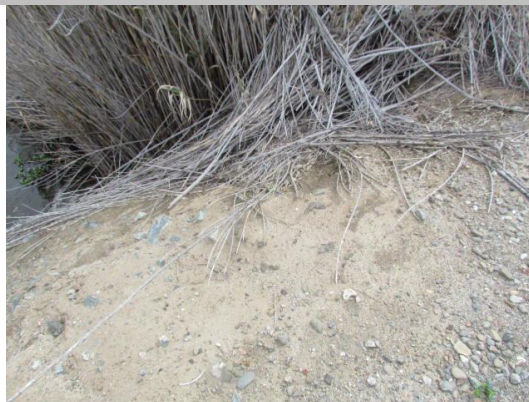
Photo 2 of 3 : SP_2017_RD0524_107_10_20170316_00018.jpg

LM Start	0.63	Rating **	U	Issue No.	10 (cont)	
LM End	0.63	Issue Type +	Ma	Location *	WS	
Category	Earthen Levee			GPS Latitude/Longitude		
				Start		End
Item	Erosion / Bank Caving			37.938247 °		37.938247 °
				-121.336503 °		-121.336503 °
DWR ID	DWR_RD0524_01_f_2015_10					
Comment Code						
E2 : Schedule repair of erosion site prior to the next inspection.						
Inspector Comment						
Erosion located next to and under bamboo.

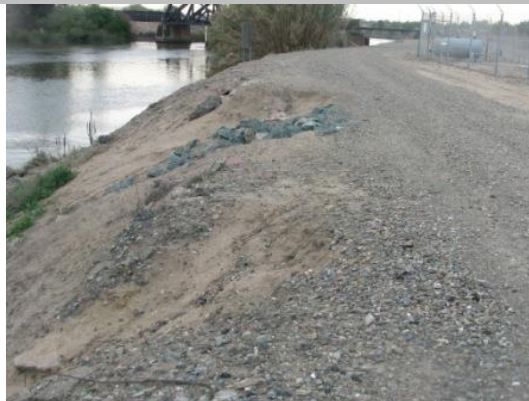
Photo 3 of 4 : SP_2017_RD0524_107_13_20170316_00028.jpg

LM Start	0.64	Rating **	M	Issue No.	13 (cont)
LM End	0.65	Issue Type +	Ma	Location *	WS
Category	Earthen Levee			GPS Latitude/Longitude	
				Start	End
Item	Slope Stability			37.938105°	37.938023°
				-121.336288°	-121.336173°
DWR ID	DWR_RD0524_01_s_2012_13				
Comment Code					
S1 : Repair slope instability.					
Inspector Comment					
Depression extend from shoulder to mid levee slope two site with this section.

View of the erosion.

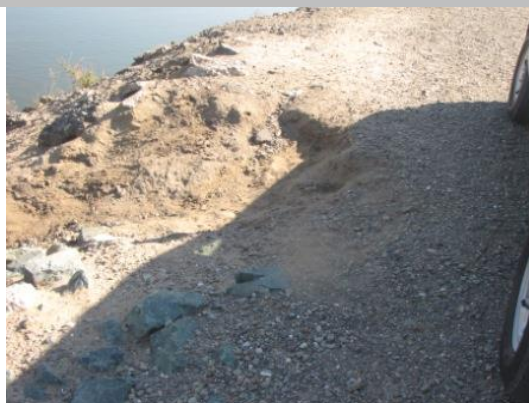
Photo 4 of 4 : SP_2017_RD0524_107_13_20170316_00029.jpg

Update view of the erosion site.

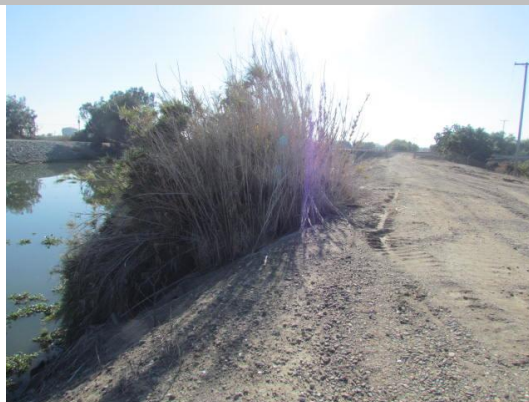
Photo 1 of 3 : SP_2017_RD0524_107_14_20170316_00030.jpg

LM Start	0.67	Rating **	U	Issue No.	14
LM End	0.67	Issue Type +	Ma	Location *	WS
Category	Earthen Levee			GPS Latitude/Longitude	
				Start	End
Item	Vegetation			37.937808 °	37.937808 °
				-121.335913 °	-121.335913 °
DWR ID	DWR_RD0524_01_s_2012_14				
Comment Code					
V2 : Remove the wild growth other than native grasses from the levee slopes.					
Inspector Comment					
Bamboo on waterward slope.Bamboo has been killed but still blocking view of levee slope.

Looking south at dying bamboo on waterward slope. Fall 2015

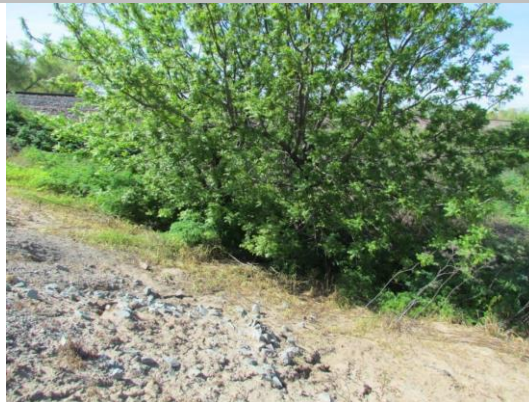
Photo 1 of 1 : SP_2017_RD0524_107_156_20170407_00382.jpg

LM Start	0.72	Rating **	U	Issue No.	156
LM End	0.72	Issue Type +	Ma	Location *	LS
Category	Earthen Levee			GPS Latitude/Longitude	
				Start	End
Item	Trim / Thin Trees			37.937258 °	37.937258 °
				-121.335373 °	-121.335373 °
DWR ID	DWR_RD0524_01_s_2017_156				
Comment Code					
T1 : Trim trees to at least five feet above ground level.					
Inspector Comment					
Dense veg on landward slope.

Looking west at dense untrimmed tree on landward slope.

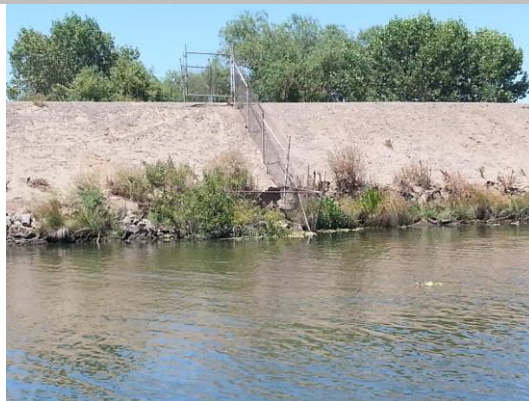
Photo 1 of 2 : SP_2017_RD0524_107_21_20170316_00044.jpg

07/25/2016: No significant change observed.
 06/24/2015: No significant change observed.
 06/19/2014: No significant change observed.
 08/13/2013: No significant change at this site.
 08/07/2012: The site has been visited by boat survey. No significant change observed.
 08/23/2011: The site is located immediately upstream of a Railroad bridge. Dense vegetation at the water line blocks the view of erosion.
 [2016 Site ID:RD0524U01RM41.39]

Front view of the erosion site.

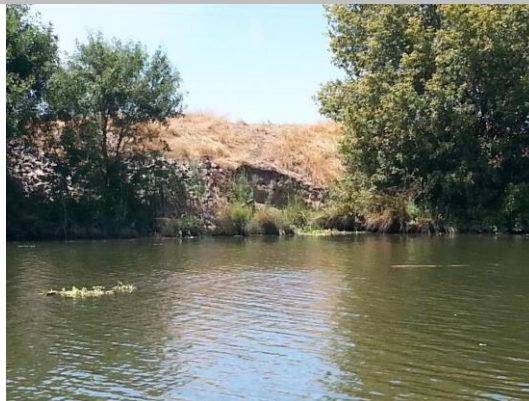
Photo 1 of 2 : SP_2017_RD0524_107_33_20170316_00063.jpg

LM Start	0.91	Rating **	U	Issue No.	33
LM End	0.91	Issue Type +	Ma	Location *	WS
Category	Supplemental			GPS Latitude/Longitude	
				Start	End
Item	DWR Erosion Survey			37.935576 °	37.935576 °
				-121.333202 °	-121.333202 °
DWR ID	DWR_RD0524_01_s_2017_33				
Comment Code					
Inspector Comment					
07/25/2016: No significant change observed.					
06/24/2015: No significant change observed.					
06/19/2014: No significant change observed.					
08/13/2013: No significant change at this site.					
08/07/2012: The site has been visited by boat survey. No significant change observed					
08/23/2011: The erosion site is immediately downstream of the riprap protection. [2016 Site ID:RD0524U01RM41.5]

Front view of the erosion. Note the riprap protection near the site.

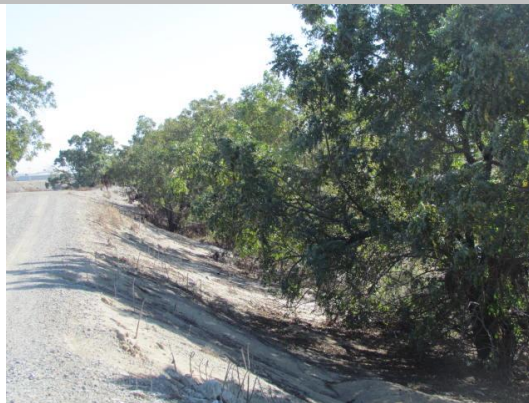
Photo 1 of 1 : SP_2017_RD0524_107_77_20170316_00125.jpg

Looking south at low hanging tree branches at landside toe.

LM Start	0.93	Rating **	U	Issue No.	77
LM End	1.01	Issue Type +	Ma	Location *	LS
Category	Earthen Levee			GPS Latitude/Longitude	
				Start	End
Item	Trim / Thin Trees			37.935259 °	37.935049 °
				-121.332864 °	-121.331334 °
DWR ID	DWR_RD0524_01_s_2012_77				
Comment Code					
T1 : Trim trees to at least five feet above ground level.					
Inspector Comment

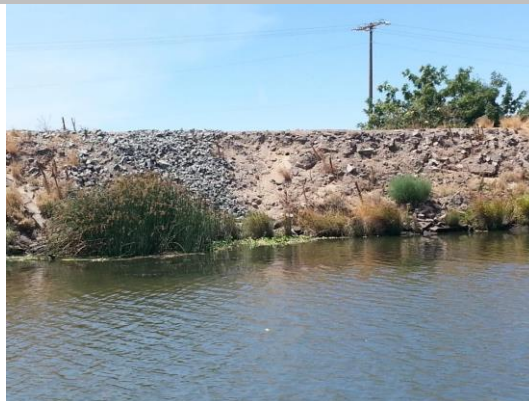
Photo 2 of 3 : SP_2017_RD0524_107_55_20170316_00100.jpg

LM Start	1.02	Rating **	U	Issue No.	55 (cont)
LM End	1.02	Issue Type +	Ma	Location *	WS
Category	Supplemental			GPS Latitude/Longitude	
				Start	End
Item	DWR Erosion Survey			37.935078 °	37.935078 °
				-121.331134 °	-121.331134 °
DWR ID	DWR_RD0524_01_s_2017_55				
Comment Code					
Inspector Comment					
07/25/2016: No significant change observed.					
06/24/2015: No significant change observed.					
06/19/2014: No significant change observed.					
08/13/2013: No significant change at this site.					
08/07/2012: The site has been visited by boat survey. Site has been repaired, but new erosion occurred at the levee slope and immediately upstream of the repaired site.					
08/23/2011: The site is about 500 ft downstream of bridge. The levee toe seems to be protected, but the protection is being washed away.					
[2016 Site ID:RD0524U01RM41.59]

Close view of the erosion.

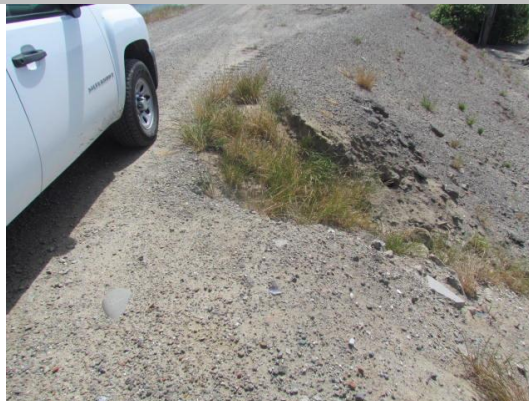
Photo 4 of 7 : SP_2017_RD0524_107_18_20170316_00037.jpg

LM Start	1.07	Rating **	U	Issue No.	18 (cont)	
LM End	1.07	Issue Type +	Ma	Location *	LS	
Category	Earthen Levee			GPS Latitude/Longitude		
				Start		End
Item	Slope Stability			37.934715 °		37.934715 °
				-121.330343 °		-121.330343 °
DWR ID	DWR_RD0524_01_s_2012_18					
Comment Code						
S1 : Repair slope instability.						
Inspector Comment						
Slope damage extend from shoulder to middle of slope.

Looking south at caving on landward shoulder. (Spring 2015)

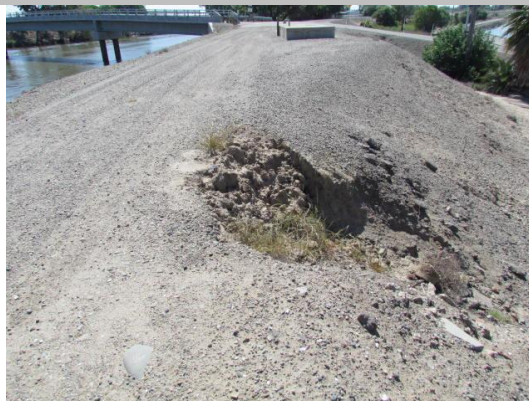
Photo 5 of 7 : SP_2017_RD0524_107_18_20170316_00040.jpg

Looking south at caving on landside shoulder. (Spring 2013)

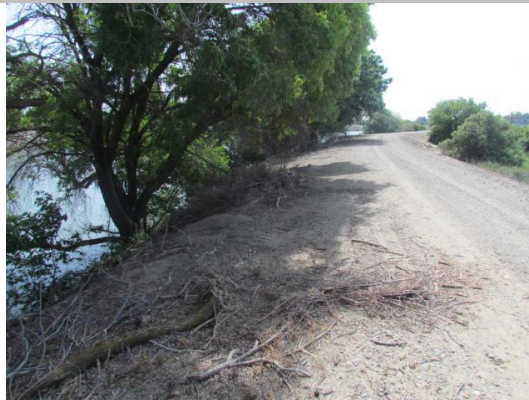
Photo 1 of 1 : SP_2017_RD0524_107_171_20170316_000200.jpg

LM Start	1.12	Rating **	M	Issue No.	171
LM End	1.16	Issue Type +	Ma	Location *	WS
Category	Earthen Levee			GPS Latitude/Longitude	
				Start	End
Item	Encroachments			37.934225 °	37.933815 °
				-121.329693 °	-121.329242 °
DWR ID	DWR_RD0524_01_s_2015_171				
Comment Code					
PR : Prunings					
Inspector Comment					
Prunings left on waterward shoulder and slope.

Looking south at prunings on waterward shoulders.

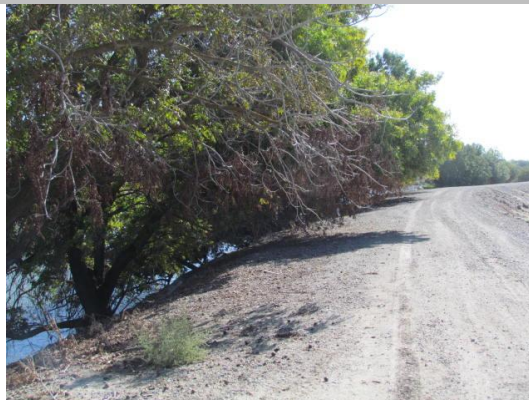
Photo 1 of 1 : SP_2017_RD0524_107_19_20170316_00043.jpg

Looking southeast at low hanging tree branches at waterside toe.

LM Start	1.13	Rating **	M	Issue No.	19
LM End	1.16	Issue Type +	Ma	Location *	WS
Category	Earthen Levee			GPS Latitude/Longitude	
				Start	End
Item	Trim / Thin Trees			37.934118 °	37.933775 °
				-121.329657 °	-121.329305 °
DWR ID	DWR_RD0524_01_s_2012_19				
Comment Code					
T1 : Trim trees to at least five feet above ground level.					
Inspector Comment

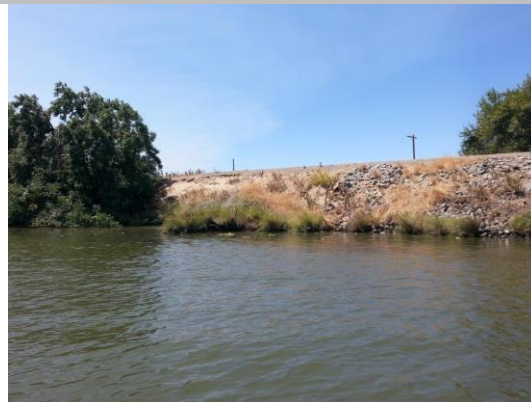
Photo 1 of 3 : SP_2017_RD0524_107_60_20170316_00105.jpg

Comment Code					
Inspector Comment					
07/25/2016: No significant change observed.					
06/24/2015: No significant change observed.					
06/19/2014: No significant change observed.					
08/13/2013: No significant change at this site.					
08/07/2012: The site has been visited by boat survey. No significant change observed					
08/23/2011: No significant change observed on site.					
09/07/2010: No significant change observed on site. Vegetation is visible at the water line. There is an exposed pipe discharge partially hanging at the mid-slope, possibly still used for discharging irrigation/runoff water. There is minimal rip rap protection along the bank, and what's left of it is no longer adequately protecting the bank.					
9/29/2009: Site consists of a 400-foot long eroding bank with minimal vegetation and protection; the existing rip rap has sloughed, rendering it useless; note that there is an exposed section of a pipe.

10/18/2006: There is extensive loss of rip rap on some sections; sewage disposal pond is on the landside of the levee; there is an exposed pipe outlet "hanging" from the upper slope. [2016 Site ID:RD0524U01RM41.79]

Direct view of the site.

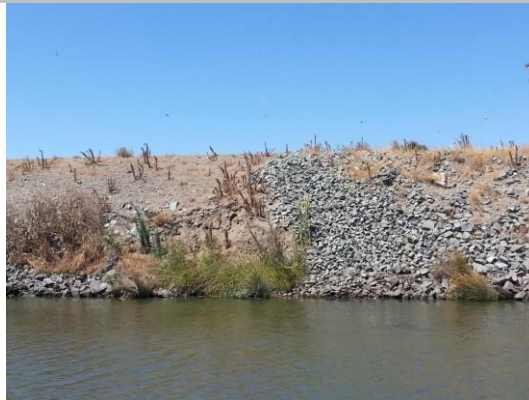
Photo 1 of 3 : SP_2017_RD0524_107_71_20170316_00115.jpg

LM Start	1.29	Rating **	U	Issue No.	71
LM End	1.32	Issue Type +	Ma	Location *	WS
Category	Supplemental			GPS Latitude/Longitude	
				Start	End
Item	DWR Erosion Survey			37.931858 °	37.931858 °
				-121.328300 °	-121.328300 °
DWR ID	DWR_RD0524_01_s_2017_71				
Comment Code					
Inspector Comment					
07/25/2016: No significant change observed.					
06/24/2015: No significant change observed.					
06/19/2014: No significant change observed.					
08/13/2013: New signs of animal activity were found.					
08/07/2012: The site was first reported in 2012 spring levee inspection report. [2016 Site ID:RD0524U01RM41.92]

Front view of the erosion.

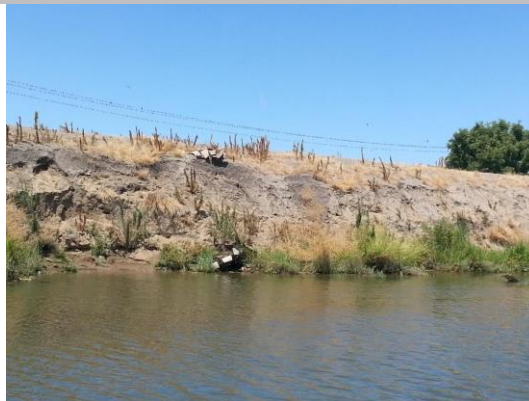
Photo 2 of 3 : SP_2017_RD0524_107_71_20170316_00116.jpg

Front view of the erosion.

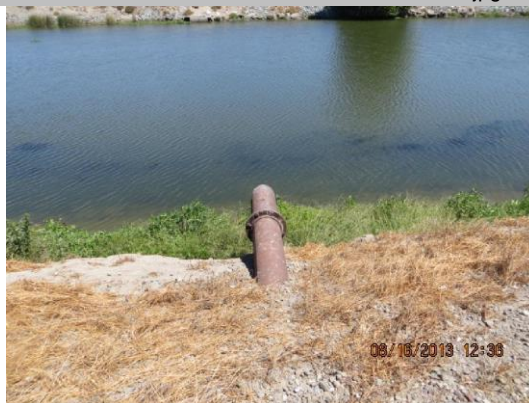
Photo 1 of 3 : UCIP_SP_2017_51319_29862.jpg

FS_ID:51319
DS_ID:20602
EP_NO: N/A
Repair Type: Urgent
Crossing Status: Found
UCIP Comments: 11/16/2016 same as previous inspection both ends are open. This pipe does not appear in use. Need to contact owner to determine status of crossing. If the crossing is abandoned or in use, owner will need to coordinate with the CVFPB to comply with Title 23 requirements. (O. Magana - DWR UCIP)08/16/2013 Pipe appears to be open on both ends. Abandoned and should be done so properly. (W. Wylie - DWR UCIP)
FIELD_STRUCT_DESC: *ABANDONED* 12-inch steel drainage pipe through levee, 3.5 feet below crown. Pipe is opened on the waterside (WS) and landside (LS) ends. The pump house referenced in O&M manual is missing from the LS (2013). [Additional Reference(s): DWR Levee Log, 2004. USACE San Joaquin River O&M Unit No. 7, April 1964, (HLM 1.31)].
FS Date: 11/16/2016

Pipe visible and open on WS slope.

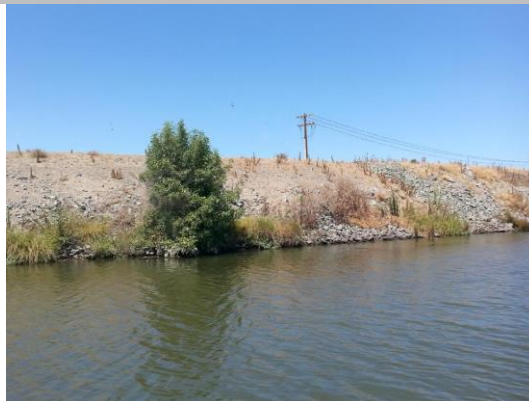
Photo 1 of 3 : SP_2017_RD0524_107_79_20170316_00127.jpg

LM Start	1.39	Rating **	U	Issue No.	79
LM End	1.39	Issue Type +	Ma	Location *	WS
Category	Supplemental			GPS Latitude/Longitude	
				Start	End
Item	DWR Erosion Survey			37.930575 °	37.930575 °
				-121.328090 °	-121.328090 °
DWR ID	DWR_RD0524_01_s_2017_79				
Comment Code					
Inspector Comment					
07/25/2016: No significant change observed					
06/24/2015: No significant change observed.					
06/19/2014: No significant change observed.					
08/13/2013: No significant change observed.					
08/07/2012: The site was first reported in 2012 spring levee inspection report. The site is located about 750 ft downstream of SR 4 Bridge.					
[2016 Site ID:RD0524U01RM42.03]

Front view of the erosion.

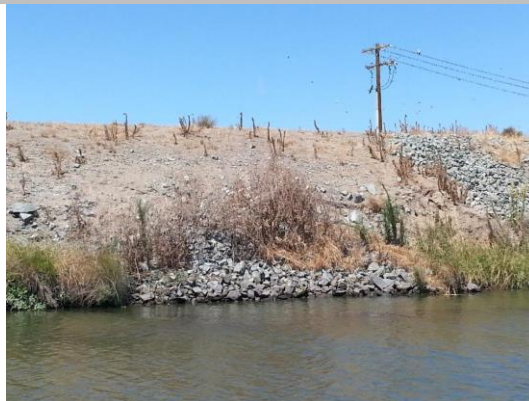
Photo 3 of 3 : SP_2017_RD0524_107_79_20170316_00129.jpg

Close view of the erosion.

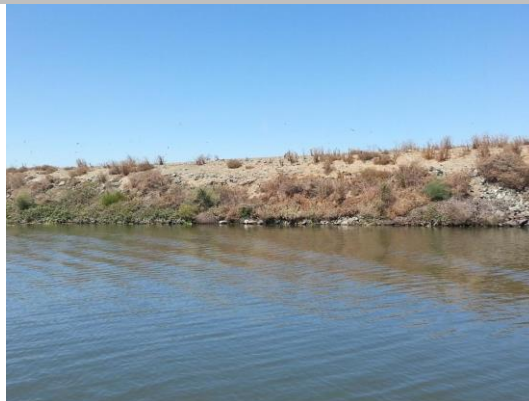
Photo 2 of 2 : SP_2017_RD0524_107_89_20170316_00143.jpg

LM Start	1.45	Rating **	U	Issue No.	89 (cont)
LM End	1.47	Issue Type +	Ma	Location *	WS
Category	Supplemental			GPS Latitude/Longitude	
				Start	End
Item	DWR Erosion Survey			37.929650 °	37.929650 °
				-121.328110 °	-121.328110 °
DWR ID	DWR_RD0524_01_s_2017_89				
Comment Code					
Inspector Comment					
07/25/2016: No significant change observed.					
06/24/2015: No significant change observed.					
06/19/2014: No significant change observed.					
08/13/2013: The site is located approximately 400 ft. downstream SR 4 Bridge. Dense vegetation is visible at the toe. [2016 Site ID:RD0524U01RM42.09]

Close view of the erosion.

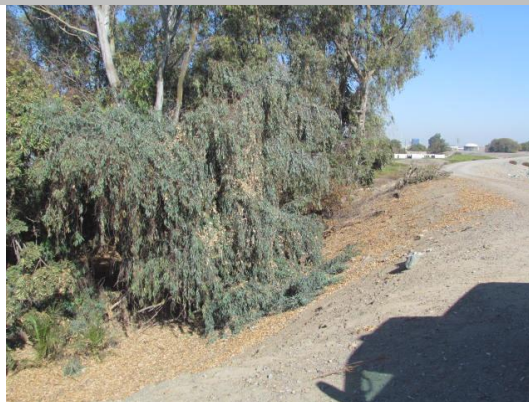
Photo 1 of 4 : SP_2017_RD0524_107_916_20170316_00273.jpg

LM Start	1.49	Rating **	U	Issue No.	916
LM End	1.49	Issue Type +	Ma	Location *	LS
Category	Earthen Levee			GPS Latitude/Longitude	
				Start	End
Item	Trim / Thin Trees			37.929118 °	37.929118 °
				-121.328368 °	-121.328368 °
DWR ID	DWR_RD0524_01_s_2012_916				
Comment Code					
T3 : Trim and thin trees to allow visibility of the ground and room to flood fight.					
Inspector Comment					
Untrimmed trees and dense vegetation on landward toe.

Looking at dense trees on landward slope and toe fall 2015

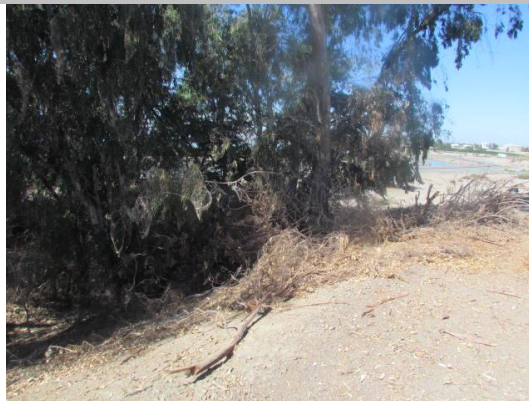
Photo 2 of 4 : SP_2017_RD0524_107_916_20170316_00274.jpg

Looking at trees on landside slope. (Fall 2012)

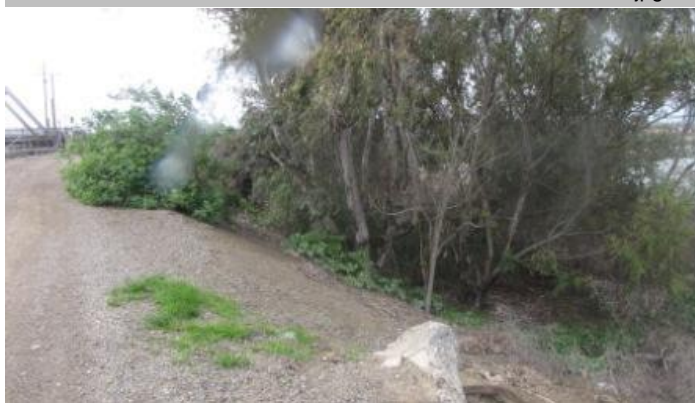
Photo 3 of 4 : SP_2017_RD0524_107_916_20170316_00275.jpg

Looking at dense veg. on landside slope and toe.

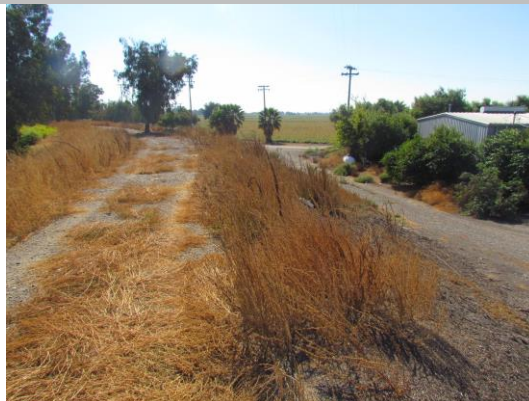
Photo 1 of 1 : SP_2017_RD0524_107_23_20170316_00048.jpg

LM Start	1.55	Rating **	A/W	Issue No.	23
LM End	1.59	Issue Type +	Ma	Location *	LS
Category	Earthen Levee			GPS Latitude/Longitude	
				Start	End
Item	Vegetation			37.928388 °	37.927797 °
				-121.328280 °	-121.327854 °
DWR ID	DWR_RD0524_01_s_2012_23				
Comment Code					
V2 : Remove the wild growth other than native grasses from the levee slopes.					
Inspector Comment					
Dense vegetation on landward slope.

Looking southwest at dense veg on landward slope. (Fall 2016)

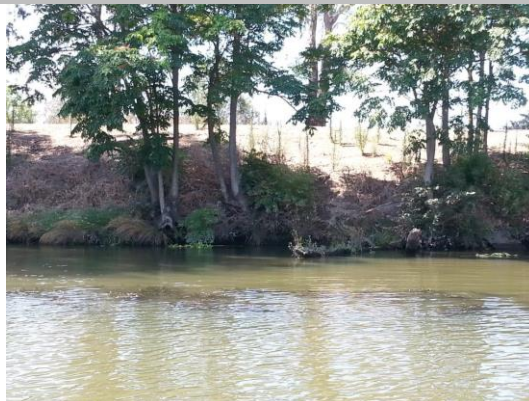
Photo 3 of 3 : SP_2017_RD0524_107_90_20170316_00146.jpg

Comment Code						
Inspector Comment						
07/25/2016: No significant change observed.						
06/24/2015: No significant change observed.						
06/19/2014: No significant change observed.						
08/13/2013: No significant change observed.						
08/07/2012: The site has been visited by boat survey. No significant change observed						
08/23/2011: No significant change observed on site. Trees concerned still in place.						
09/07/2010: No significant change observed on site. The concern here is the undermining of the levee toe where most of trees are. There are erosion pockets lined along the lower slope and at the base of the trees, exposing tree roots. There is minimal slope protection.						
09/29/2009: The lower slope is lined with minor erosion pockets; some tree roots are exposed; there is visible undermining of the levee toe; site is immediately upstream of the Highway 4 Bridge; the bridge is possibly causing a scour to occur, eroding the bank. [2016 Site ID:RD0524U01RM42.2]

Close view of the erosion at the levee toe.

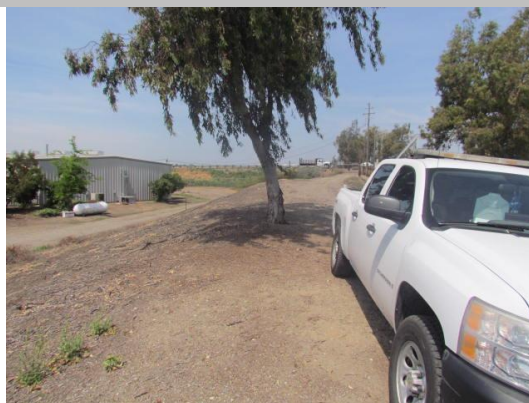
Photo 1 of 1 : SP_2017_RD0524_107_173_20170316_00203.jpg

LM Start	1.58	Rating **	U	Issue No.	173
LM End	1.58	Issue Type +	Ma	Location *	LS
Category	Earthen Levee			GPS Latitude/Longitude	
				Start	End
Item	Trim / Thin Trees			37.927975 °	37.927975 °
				-121.328088 °	-121.328088 °
DWR ID	DWR_RD0524_01_s_2015_173				
Comment Code					
T1 : Trim trees to at least five feet above ground level.					
Inspector Comment					
Tree is located on landward shoulder and crown should be removed.

Looking northwest at tree on within levee crown.

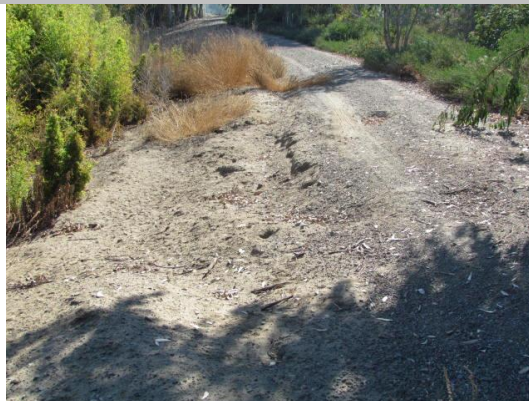
Photo 1 of 1 : SP_2017_RD0524_107_136_20170316_00193.jpg

LM Start	1.59	Rating **	M	Issue No.	136
LM End	1.59	Issue Type +	Ma	Location *	CR
Category	Earthen Levee			GPS Latitude/Longitude	
				Start	End
Item	Slope Stability			37.927775 °	37.927775 °
				-121.327860 °	-121.327860 °
DWR ID	DWR_RD0524_01_s_2013_136				
Comment Code					
S2 : Repair the levee slope damaged by foot traffic and prevent access where possible.					
Inspector Comment					
Waterward shoulder caving.

Looking south at depression on levee crown near waterward shoulder.

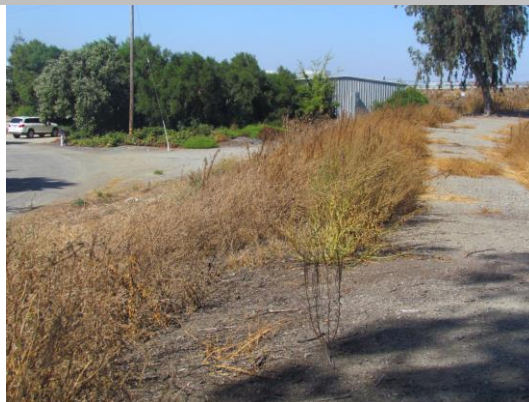
Photo 1 of 1 : SP_2017_RD0524_107_24_20170316_00049.jpg

LM Start	1.60	Rating **	U	Issue No.	24
LM End	1.61	Issue Type +	Ma	Location *	LS
Category	Earthen Levee			GPS Latitude/Longitude	
				Start	End
Item	Vegetation			37.927635 °	37.927540 °
				-121.327812 °	-121.327648 °
DWR ID	DWR_RD0524_01_s_2012_24				
Comment Code					
V2 : Remove the wild growth other than native grasses from the levee slopes.					
Inspector Comment					
Vegetation blocking landward toe.

Looking northwest at dense veg on waterward slope.

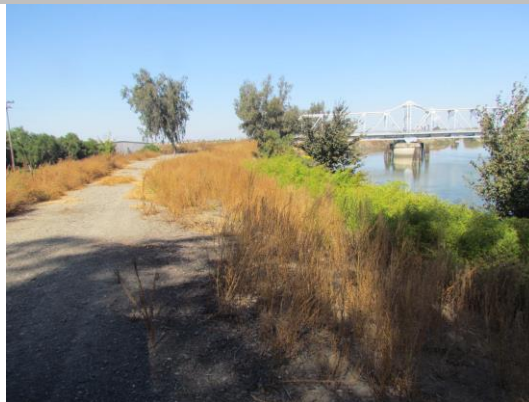
Photo 1 of 3 : SP_2017_RD0524_107_25_20170316_00050.jpg

LM Start	1.60	Rating **	U	Issue No.	25
LM End	1.61	Issue Type +	Ma	Location *	WS
Category	Earthen Levee			GPS Latitude/Longitude	
				Start	End
Item	Vegetation			37.927635 °	37.927540 °
				-121.327812 °	-121.327648 °
DWR ID	DWR_RD0524_01_s_2012_25				
Comment Code					
V2 : Remove the wild growth other than native grasses from the levee slopes.					
Inspector Comment

Looking northwest at dense veg on waterward slope.

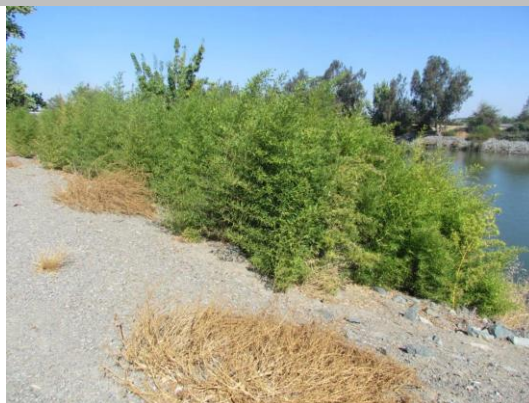
Photo 2 of 3 : SP_2017_RD0524_107_25_20170316_00051.jpg

Looking northwest at end of dense veg on waterward slope.

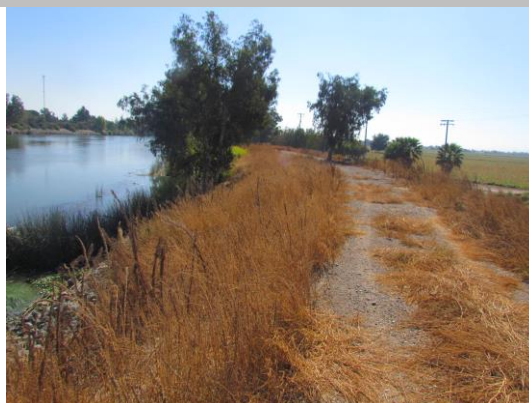
Photo 3 of 3 : SP_2017_RD0524_107_25_20170316_00052.jpg

Looking southwest at dense veg on waterward slope.

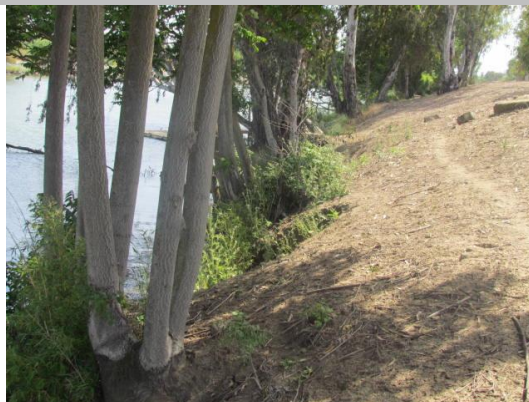
Photo 1 of 3 : SP_2017_RD0524_107_26_20170316_00053.jpg

LM Start	1.62	Rating **	M	Issue No.	26
LM End	1.64	Issue Type +	Ma	Location *	WS
Category	Earthen Levee			GPS Latitude/Longitude	
				Start	End
Item	Erosion / Bank Caving			37.927507 °	37.927295 °
				-121.327593 °	-121.327298 °
DWR ID	DWR_RD0524_01_s_2012_26				
Comment Code					
E1 : Note and monitor erosion site.					
Inspector Comment					
Several erosions along this reach.

Looking south at waterward erosion.

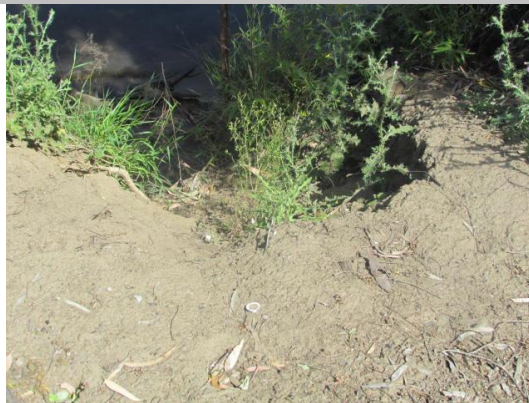
Photo 2 of 3 : SP_2017_RD0524_107_26_20170316_00054.jpg

Looking east at waterward erosion.

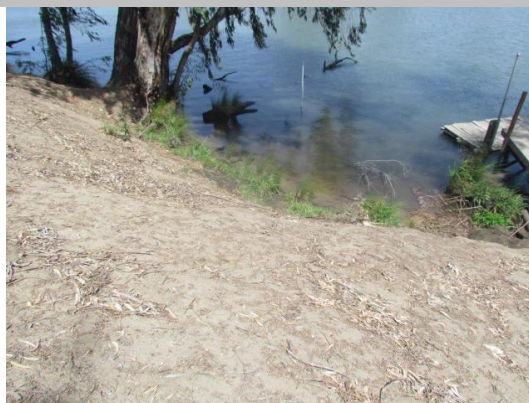
Photo 3 of 3 : SP_2017_RD0524_107_26_20170316_00055.jpg

Looking east at waterward erosion and depression.

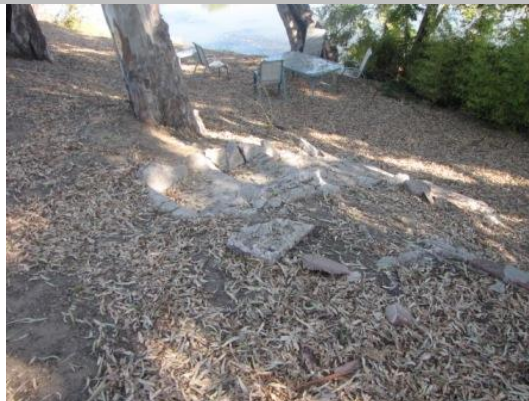
Photo 1 of 3 : SP_2017_RD0524_107_45_20170316_00082.jpg

Looking northeast at non-permitted concrete stairs on waterside slope.

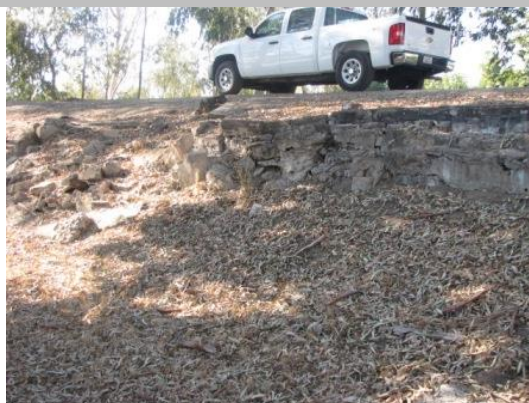
Photo 2 of 3 : SP_2017_RD0524_107_45_20170316_00083.jpg

Looking southwest at retaining wall connected to concrete stairs.

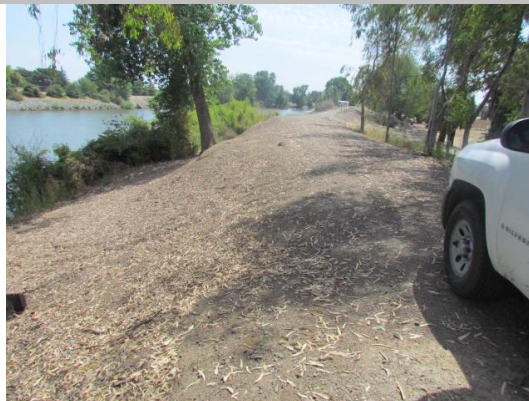
Photo 1 of 1 : SP_2017_RD0524_107_27_20170316_00056.jpg

LM Start	1.69	Rating **	M	Issue No.	27
LM End	1.70	Issue Type +	Ma	Location *	WS
Category	Earthen Levee			GPS Latitude/Longitude	
				Start	End
Item	Slope Stability			37.926728 °	37.926730 °
				-121.326597 °	-121.326508 °
DWR ID	DWR_RD0524_01_s_2012_27				
Comment Code					
S1 : Repair slope instability.					
Inspector Comment					
Slope damage several feet long and greater than one inch deep.

Looking south at landward slope depression.

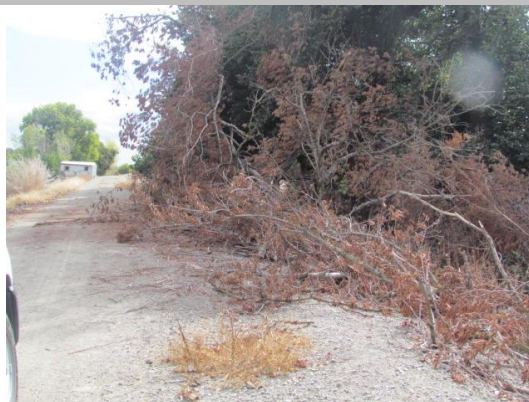
Photo 1 of 4 : SP_2017_RD0524_107_46_20170316_00085.jpg

LM Start	1.75	Rating **	U	Issue No.	46
LM End	1.76	Issue Type +	Ma	Location *	LS
Category	Earthen Levee			GPS Latitude/Longitude	
				Start	End
Item	Encroachments			37.926152 °	37.925993 °
				-121.325927 °	-121.325777 °
DWR ID	DWR_RD0524_01_s_2012_46				
Comment Code					
TR : Tree or limb					
Inspector Comment					
Downed tree limbs on landward slope.

Looking south at tree limbs on landward slope.

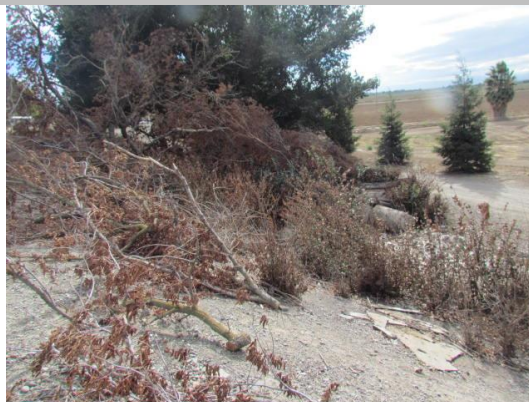
Photo 2 of 4 : SP_2017_RD0524_107_46_20170316_00086.jpg

Looking southwest at tree limbs on landward slope.

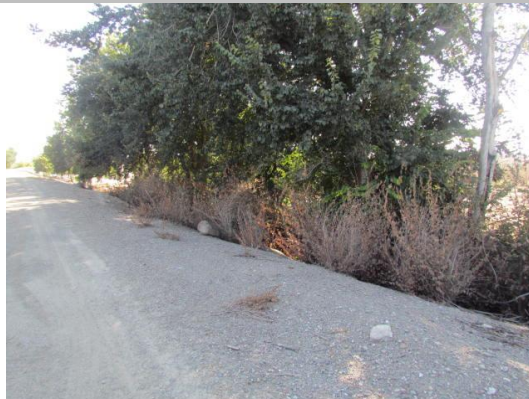
Photo 4 of 4 : SP_2017_RD0524_107_46_20170316_00088.jpg

Looking southwest at dense vegetation and low hanging tree branches on landside slope and toe.

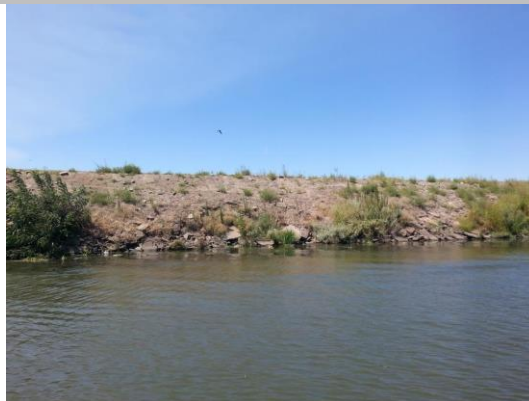
Photo 2 of 2 : SP_2017_RD0524_107_91_20170316_00148.jpg

LM Start	2.19	Rating **	U	Issue No.	91 (cont)
LM End	2.19	Issue Type +	Ma	Location *	WS
Category	Supplemental			GPS Latitude/Longitude	
				Start	End
Item	DWR Erosion Survey			37.920992 °	37.920992 °
				-121.321370 °	-121.321370 °
DWR ID	DWR_RD0524_01_s_2017_91				
Comment Code					
Inspector Comment					
07/25/2016: No significant change observed.					
06/24/2015: No significant change observed.					
07/22/2014: The erosion has increased in size.					
08/13/2013: No significant change observed. Slightly more vegetation was visible.					
08/07/2012: The site was first reported in 2012 spring levee inspection report. [2016 Site ID:RD0524U01RM42.79]

Front view of the erosion.

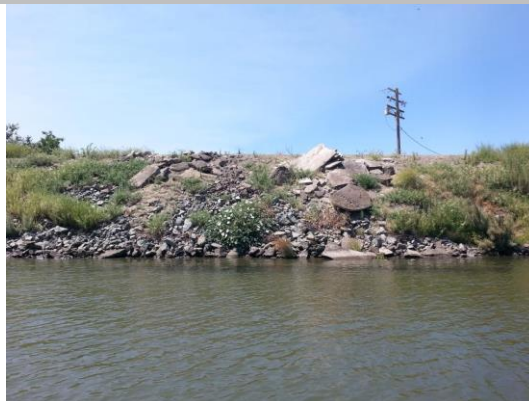
Photo 2 of 3 : SP_2017_RD0524_107_99_20170316_00159.jpg

LM Start	2.24	Rating **	U	Issue No.	99 (cont)
LM End	2.27	Issue Type +	Ma	Location *	WS
Category	Supplemental			GPS Latitude/Longitude	
				Start	End
Item	DWR Erosion Survey			37.920650 °	37.920650 °
				-121.320370 °	-121.320370 °
DWR ID	DWR_RD0524_01_s_2017_99				
Comment Code					
Inspector Comment					
0/03/20167: Site repaired					
07/25/2016: No significant change observed.					
06/24/2015: No significant change observed.					
06/19/2014: No significant change observed.					
08/13/2013: An irrigation pipe is on site. [2016 Site					
ID:RD0524U01RM42.84]

Close view of the erosion.

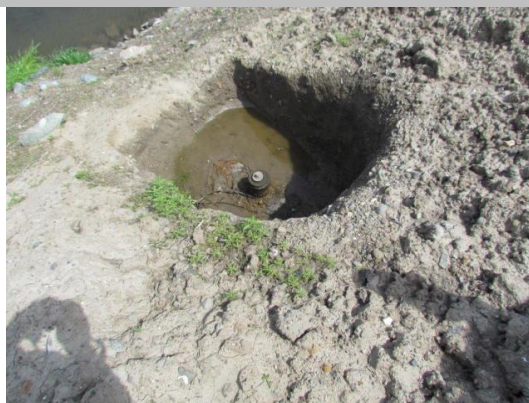
Photo 2 of 3 : SP_2017_RD0524_107_31_20170316_00059.jpg

LM Start	2.25	Rating **	U	Issue No.	31
LM End	2.25	Issue Type +	Ma	Location *	WS
Category	Earthen Levee			GPS Latitude/Longitude	
				Start	End
Item	Slope Stability			37.920493 °	37.920493 °
				-121.320565 °	-121.320565 °
DWR ID	DWR_RD0524_01_s_2012_31				
Comment Code					
S1 : Repair slope instability.					
Inspector Comment					
Slope instability probably cause by leak in irrigation pipe. Pipe should be inspected internally.

Looking east at siphon on waterward slope.

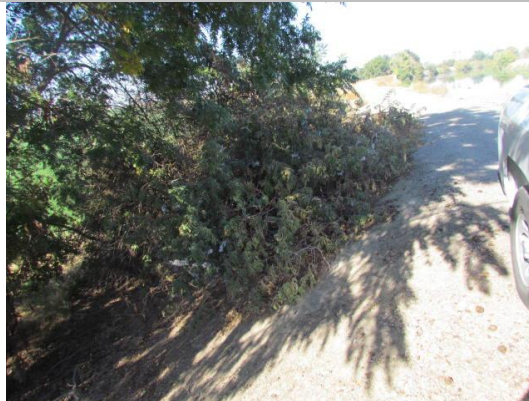
Photo 1 of 2 : SP_2017_RD0524_107_32_20170316_00061.jpg

LM Start	2.27	Rating **	U	Issue No.	32
LM End	2.29	Issue Type +	Ma	Location *	LS
Category	Earthen Levee			GPS Latitude/Longitude	
				Start	End
Item	Vegetation			37.920372 °	37.920167 °
				-121.320230 °	-121.319890 °
DWR ID	DWR_RD0524_01_s_2012_32				
Comment Code					
V4 : Elderberries are blocking visibility and flood fight capability.					
Inspector Comment					
Dense elderberry bushes on landward slope and toe.

Looking northwest at dense veg on landward slope and toe fall 2015.

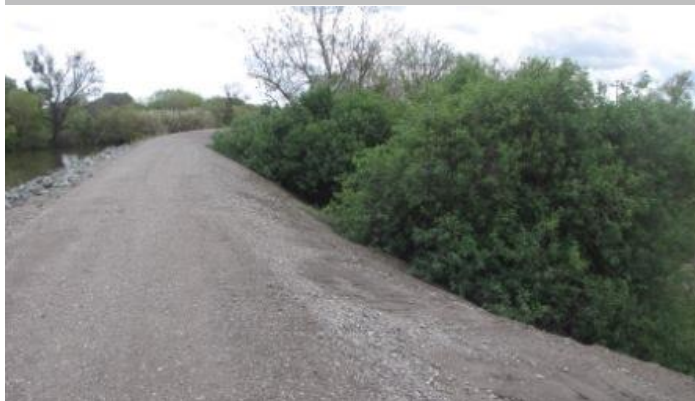
Photo 2 of 2 : SP_2017_RD0524_107_32_20170316_00062.jpg

Looking south at dense veg on landside slope and toe.

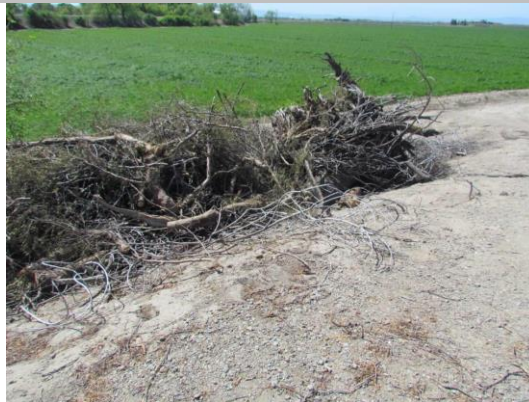
Photo 1 of 1 : SP_2017_RD0524_107_203_20170407_00385.jpg

LM Start	2.27	Rating **	U	Issue No.	203
LM End	2.27	Issue Type +	Ma	Location *	LS
Category	Earthen Levee			GPS Latitude/Longitude	
				Start	End
Item	Encroachments			37.920327 °	37.920327 °
				-121.320175 °	-121.320175 °
DWR ID	DWR_RD0524_01_f_2016_203				
Comment Code					
PR : Prunings					
Inspector Comment					
Large pruning pile on landward slope and toe.

Looking west at pruning pile on waterward slope.

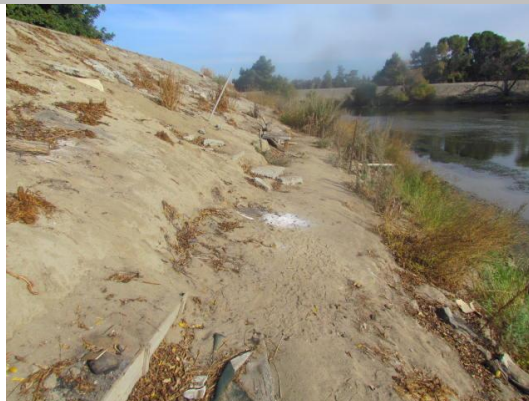
Photo 1 of 1 : SP_2017_RD0524_107_34_20170316_00065.jpg

LM Start	2.32	Rating **	M	Issue No.	34
LM End	2.33	Issue Type +	Ma	Location *	WS
Category	Earthen Levee			GPS Latitude/Longitude	
				Start	End
Item	Slope Stability			37.919885 °	37.919703 °
				-121.319713 °	-121.319702 °
DWR ID	DWR_RD0524_01_s_2012_34				
Comment Code					
S2 : Repair the levee slope damaged by foot traffic and prevent access where possible.					
Inspector Comment					
Slope damage caused by walking traffic and using bank as a fishing platform.

Looking northeast at damage to the slope possibly caused by human activity.

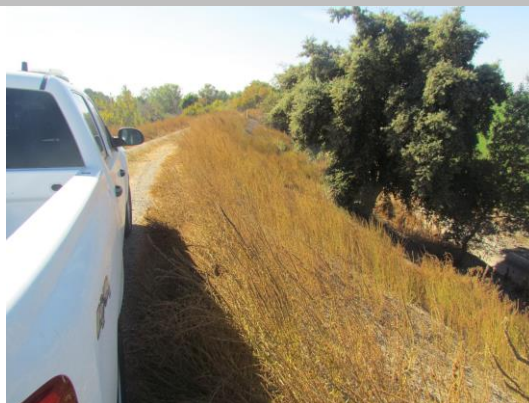
Photo 1 of 1 : SP_2017_RD0524_107_204_20170316_00236.jpg

LM Start	2.38	Rating **	U	Issue No.	204
LM End	2.42	Issue Type +	Ma	Location *	LS
Category	Earthen Levee			GPS Latitude/Longitude	
				Start	End
Item	Vegetation			37.919067 °	37.918713 °
				-121.319935 °	-121.320595 °
DWR ID	DWR_RD0524_01_f_2016_204				
Comment Code					
V2 : Remove the wild growth other than native grasses from the levee slopes.					
Inspector Comment					
Dense vegetation on landward slope and waterward slope.

Looking south at dense veg on landward slope.

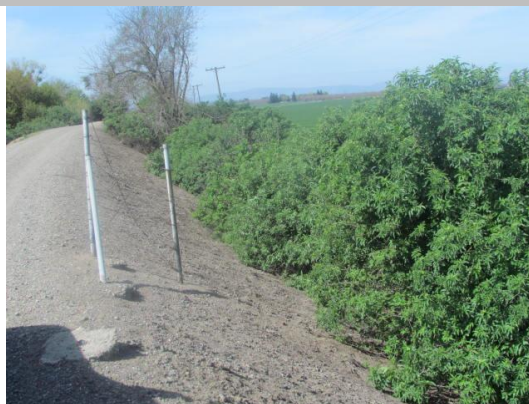
Photo 1 of 1 : SP_2017_RD0524_107_35_20170316_00066.jpg

LM Start	2.41	Rating **	U	Issue No.	35
LM End	2.45	Issue Type +	Ma	Location *	LS
Category	Earthen Levee			GPS Latitude/Longitude	
				Start	End
Item	Vegetation			37.918785 °	37.918515 °
				-121.320417 °	-121.321110 °
DWR ID	DWR_RD0524_01_s_2012_35				
Comment Code					
V4 : Elderberries are blocking visibility and flood fight capability.					
Inspector Comment

Looking southwest at dense vegetation on landward toe.

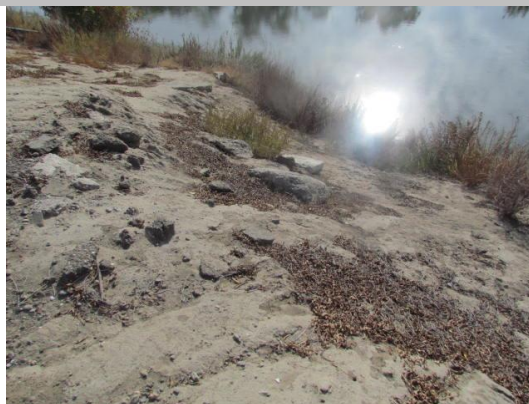
Photo 1 of 1 : SP_2017_RD0524_107_36_20170316_00067.jpg

LM Start	2.44	Rating **	M	Issue No.	36
LM End	2.47	Issue Type +	Ma	Location *	WS
Category	Earthen Levee			GPS Latitude/Longitude	
				Start	End
Item	Erosion / Bank Caving			37.918628 °	37.918438 °
				-121.320817 °	-121.321452 °
DWR ID	DWR_RD0524_01_s_2012_36				
Comment Code					
E1 : Note and monitor erosion site.					
Inspector Comment

Looking east at erosion on waterside slope.

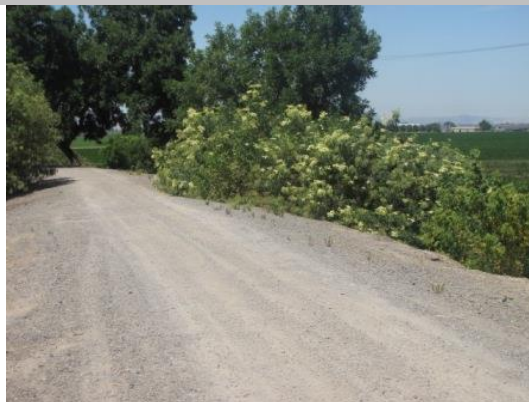
Photo 1 of 4 : SP_2017_RD0524_107_37_20170316_00068.jpg

LM Start	2.49	Rating **	U	Issue No.	37
LM End	2.50	Issue Type +	Ma	Location *	LS
Category	Earthen Levee			GPS Latitude/Longitude	
				Start	End
Item	Vegetation			37.918345 °	37.918302 °
				-121.321765 °	-121.321923 °
DWR ID	DWR_RD0524_01_s_2012_37				
Comment Code					
V4 : Elderberries are blocking visibility and flood fight capability.					
Inspector Comment

Looking south at elderberry on landside slope.

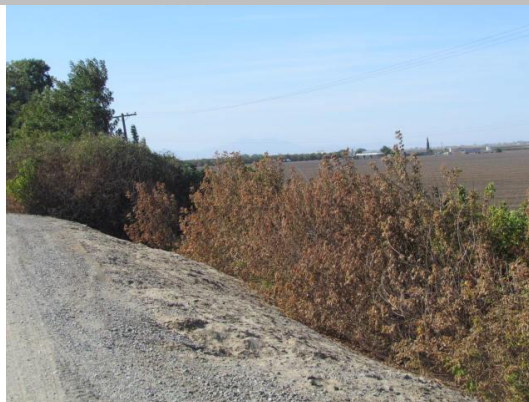
Photo 2 of 4 : SP_2017_RD0524_107_37_20170316_00069.jpg

Looking southwest at dense vegetation on landside toe.

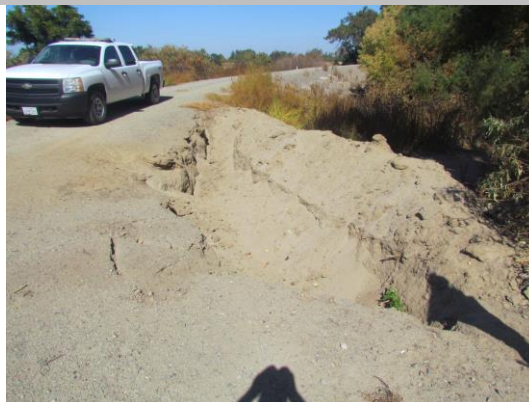
Photo 2 of 3 : SP_2017_RD0524_107_218_20170316_00256.jpg

Looking northwest at trench on waterward shoulder.
